REFURBISHMENT OF ICE STADIUM

VENTILATED FLOOR

Project: Floor refurbishment

Product used: MINIMODULO H3

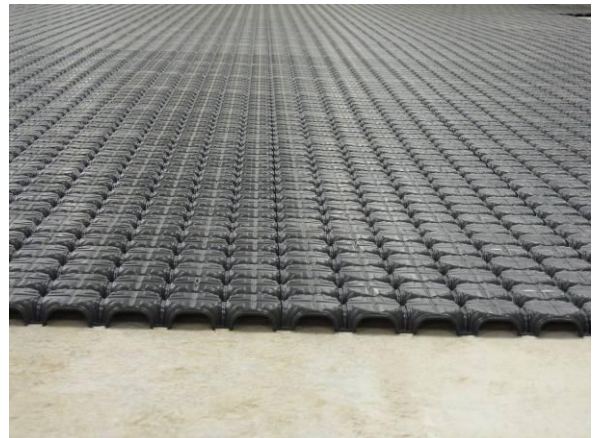
Fig. 2

Minimodulo installed on existing floor

The project required ventilation under the Ice Stadium rink. Minimodulo H3 was chosen thanks to its high load-bearing capacity, and the very low height which enabled the architect to avoid major modifications of the building – i.e. could install the system over the existing floor.

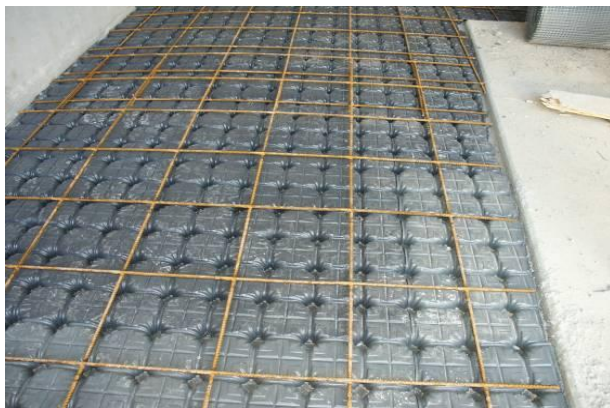
Fig. 3

System installed and ready for the pour
