OLD FARMHOUSE RENOVATION

Project: farmhouse renovation

Structure : ventilated floor

Product used: MODULO H6

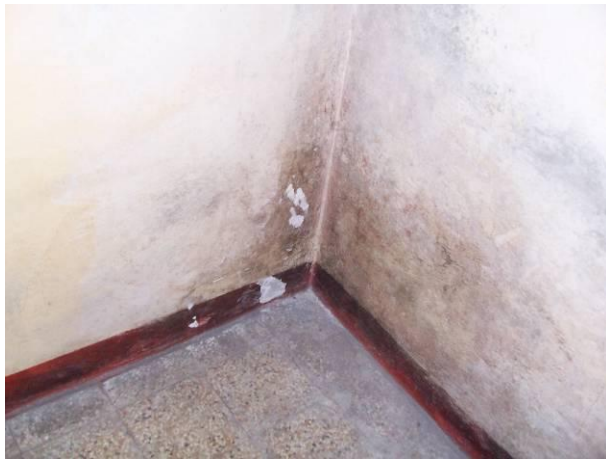
Fig. 1
State before the renovation

The problem of soil moisture raising through the walls of this farmhouse made of stone has been solved by the creation of a crawl space with Modulo H6. The renovation was simple and non-invasive.

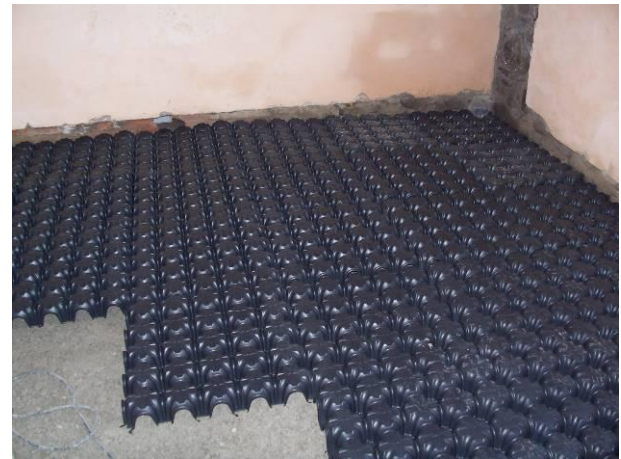
Fig. 2
Laying of Modulo

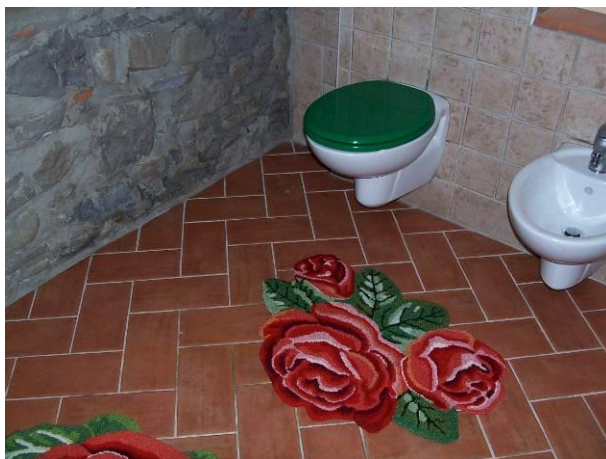
Fig. 3
Finished floor
